WWB COMPLAINT INVESTIGATION REPORT

FINDINGS & CONCLUSION (include photos and sketch as needed):

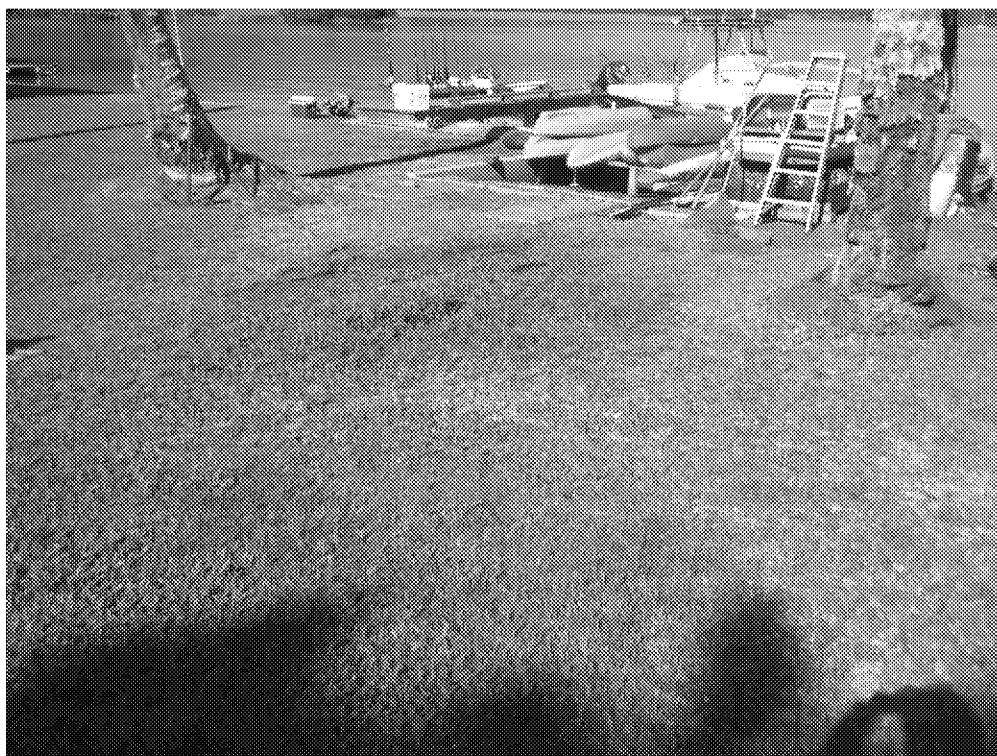
who also lives on the property were present to show the location where the alleged wastewater pools (see pic 1). At time of inspection, there were no adverse odors. The yard was damp from rain so determining whether wastewater seeped from the soil or flowed to the alleged spot could not be ascertained. Complainant had pictures

Pic 1 - location where complainant alleges wastewater pools. The spot is between the two palm trees. Property boundary to the right is about 12 to 15 feet.

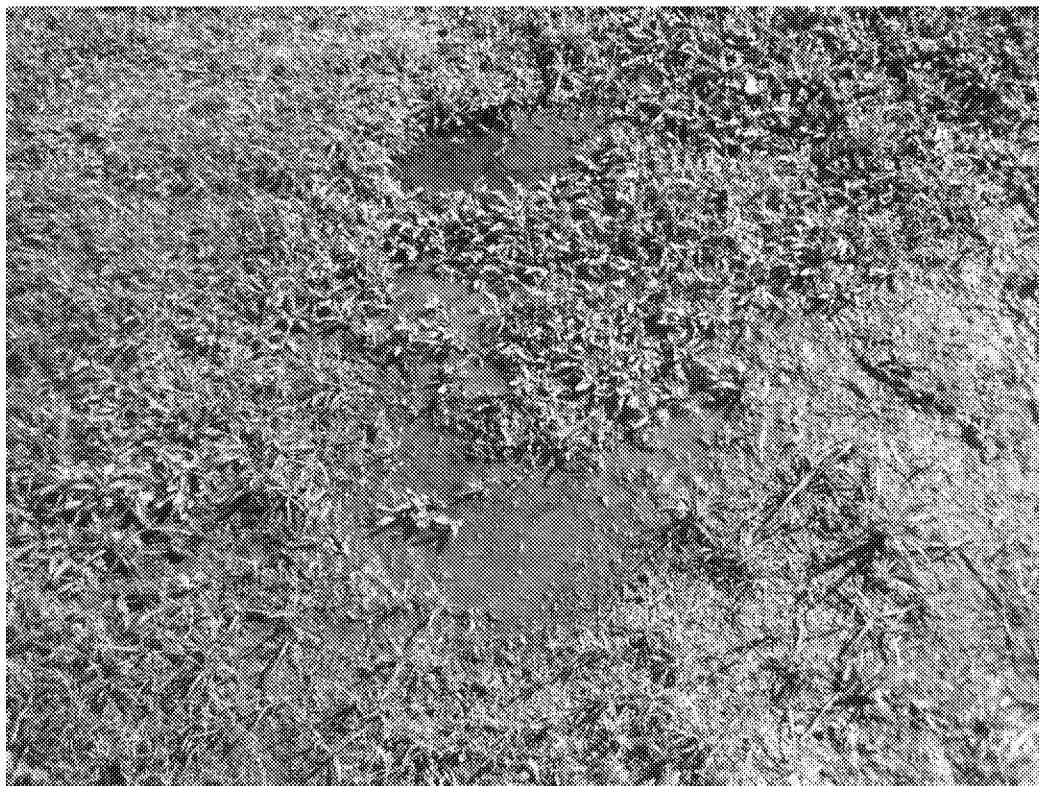
Pic 2 - close-up view of pic 1

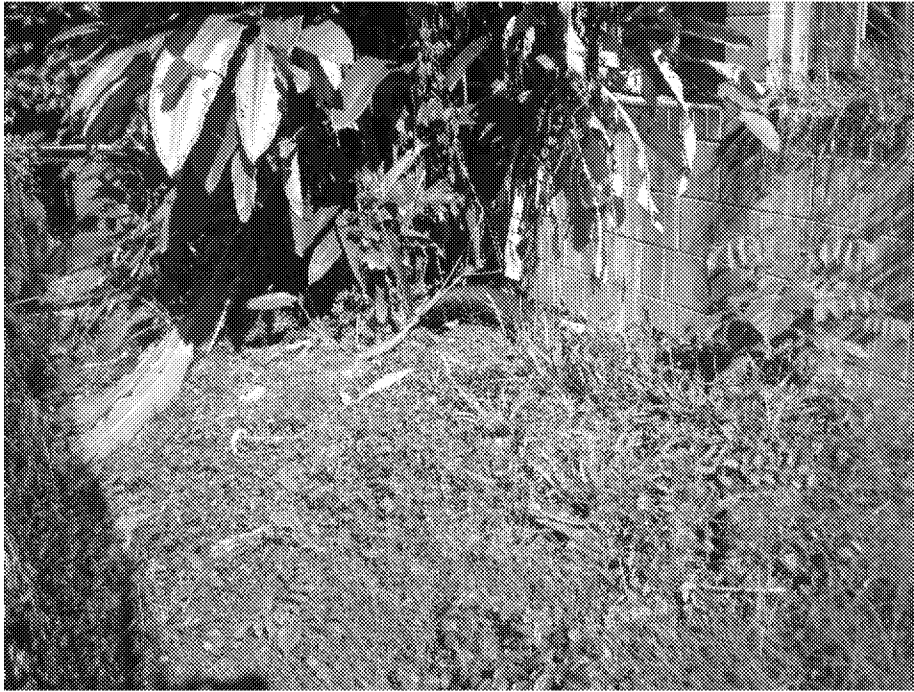
showing the spot with a whitish color. There was a black pipe (see pic 3) at the property boundary that discharges liquid into vegetation about 20 feet from alleged wastewater spot. The discharge from the black pipe may be the source of the whitish liquid (possibly laundry water).

The black pipe (see pic 3) was used to dispose laundry water. Richard indicated the black pipe initially drained excess rain water. At time of inspection, the pipe was observed to be extending to the back of the washer. He was informed not to discharge the gray water through the black pipe, so he got a hack saw and cut the line on ground level to return the black pipe’s previous function diverting rain water. There was also another black pipe for rain water from the rooftop gutters of the house (see pic 5); the rain water discharge could also be contributing liquid flow with laundry water to complainant’s property.

Pic 3 – drain pipe for laundry water

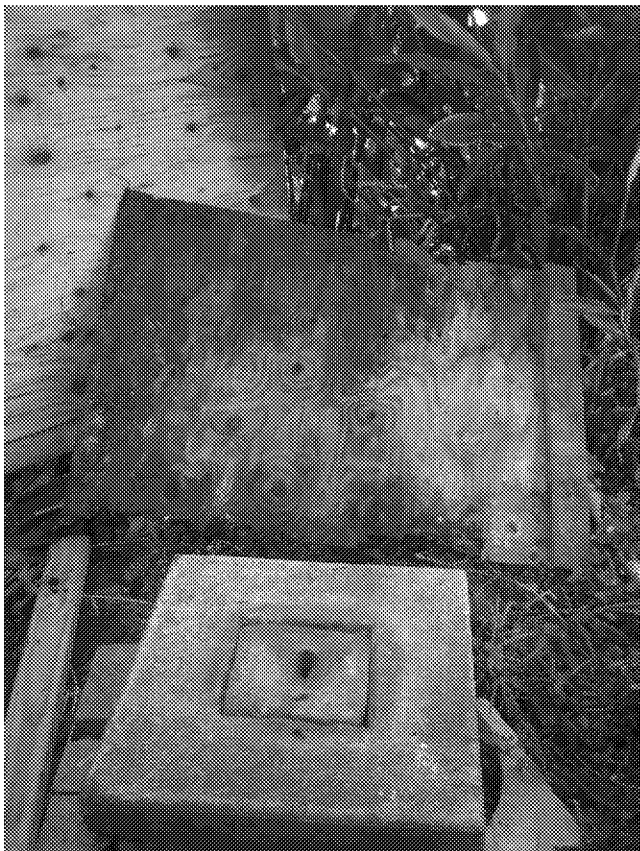
After investigating the property of the complainant, the cesspool was checked on the neighboring property. The property owner, Richard Kozuma, had the pumper truck in the morning to pump the cesspool. He indicated the cesspool is pumped every other month. At time of investigation, there did not appear to be any overflow. Complainant mentioned the cesspool may be in violation of setback requirements (9 ft.) to his property. According to complainant [REDACTED] [REDACTED] there was some dispute with his neighbor (Richard Kozuma) as to the property boundary line. (Note also that the property is located next to the shoreline and the setback distance to the ocean is 50 feet.)

On the property, there are two structures which is serviced by the cesspool. Richard bought the property in 1974 and said the cesspool was already in place for the two structures. No one permanently lives in the second structure (“cottage”) which is used only when his grandson visits. C&C DPP site shows 2 single family dwellings, year built 1956.

Since the cesspool is “grandfathered”, the cesspool setback requirements are not enforced. However, the cesspool is an LCC for servicing two dwellings and thus, the case will be referred to EPA.

Pic 4 – cesspool

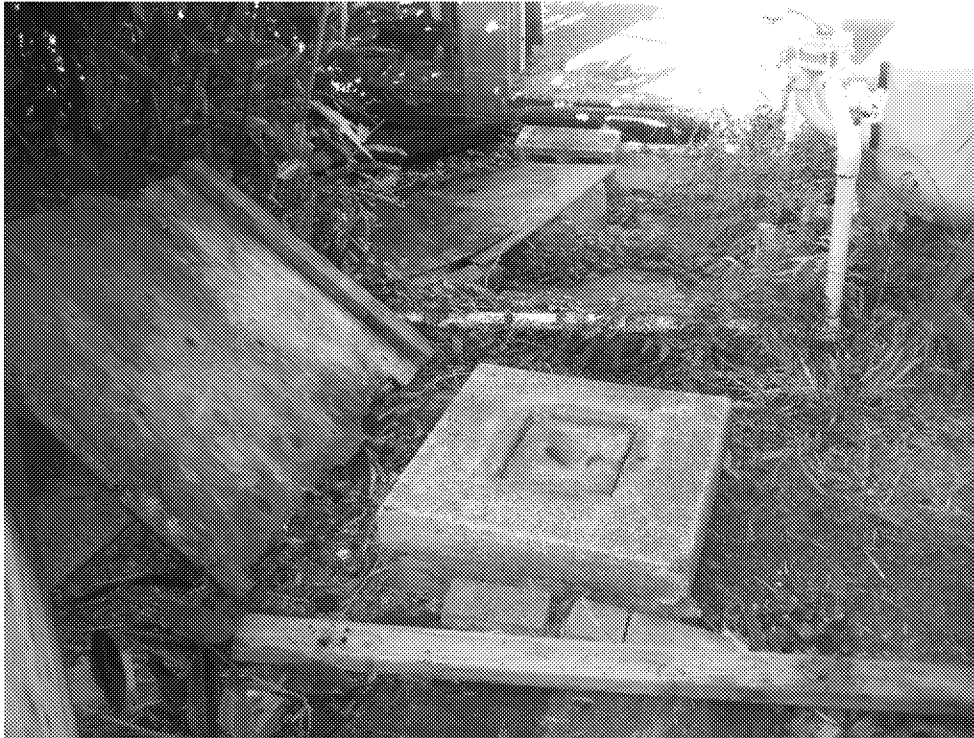
Pic 5 - black pipe for rain water at rooftop gutters. The pipe is located near the cesspool and discharges near the property boundary
